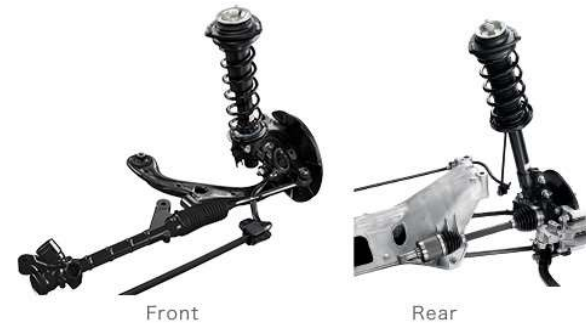
Small particle sludge mixed with coolant for washing tools when they are exchanged. A shaft gap was produced by sludge which caused defective products. The shaft gap disappeared after installing the FILSTAR and the defective parts processing fell to zero.

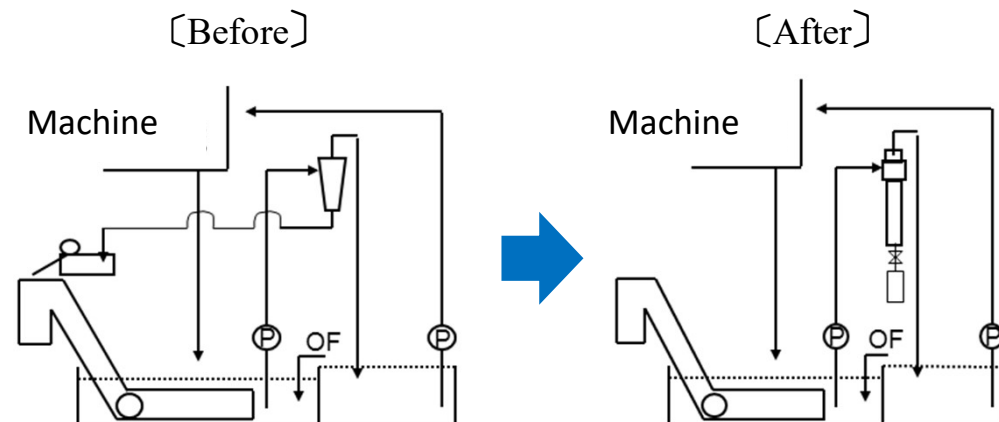
Flow chart information

Cyclone filter and Magnetic separator were installed before the FILSTAR was introduced.

Removed cyclone and Magnetic separator and installed the TK Filter with a drain cup to easily dispose of the contaminants.

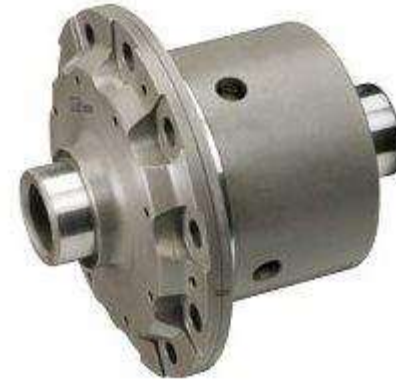
Filtration quality was poor by the existing cyclone, and a malfunction occurred at the time of screw processing. In addition, it was necessary to clean the sludge sediment in the tank once a week.

After the FILSTAR installation, malfunctioning of the screw processing became approximately 0, the tank cleaning was reduced to half, and personnel expenses were reduced.

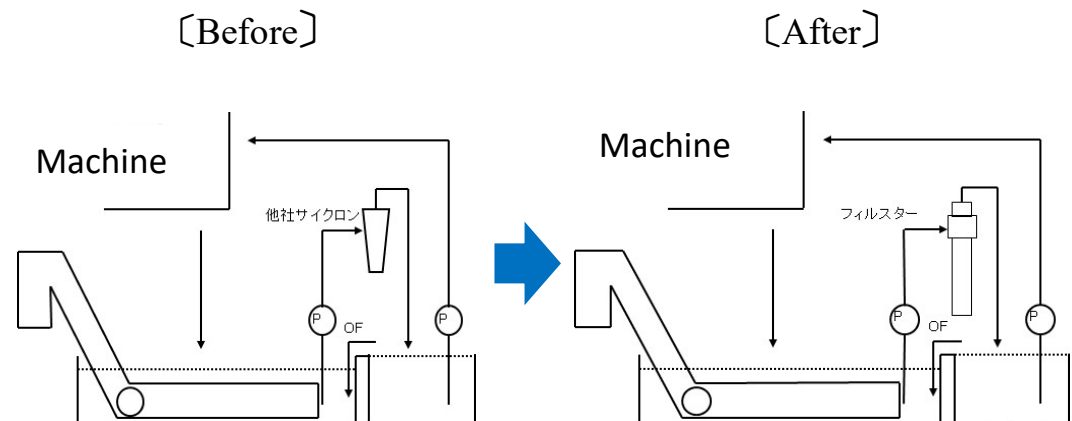
Flow chart information

Cyclonic filter was installed previously without success.
Removed existing cyclone and installed the TK Filter and a drain cup.

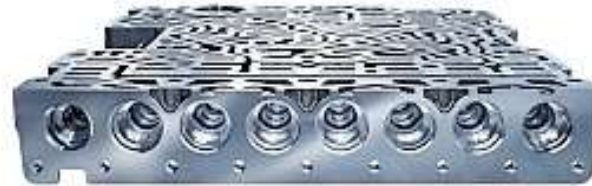
Existing cyclonic filter efficiency was poor causing a secondary filter to be exchanged once a day. The poor filtration efficiency caused the washing machine tanks to be cleaned about once a month. The washing liquid improved cleanliness by about 40%, as well as significant reduction in maintenance for exchanging the secondary filter once every three months. This greatly reduced the cost of operating the machines.

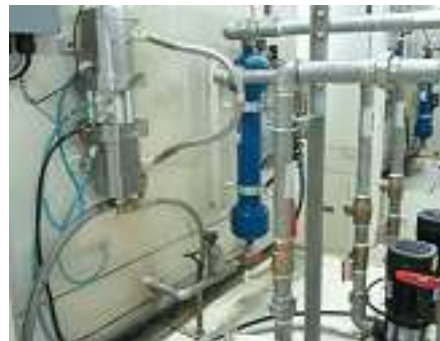
[Before]

It had a cyclonic filter with secondary media filter.

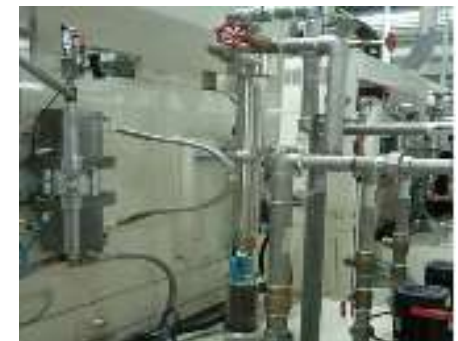
[After]

Removed the cyclonic filter and replaced it with the TK Filter.

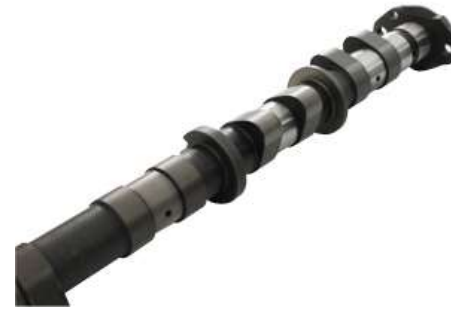
Filtration efficiency was poor, causing a secondary filter to be changed and for the tank to be cleaned monthly. Collection of the sludge improved more than 80% and fixed the blocking of the second filter and was able to reduce the running cost.

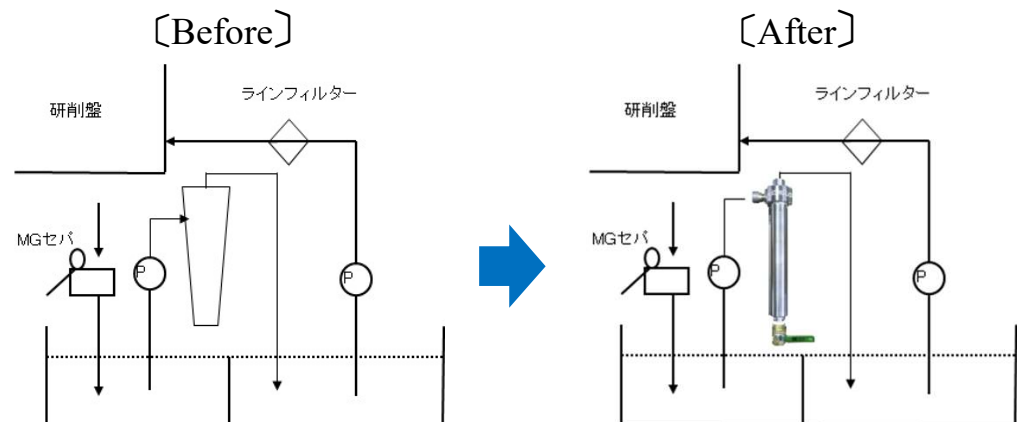
Flow chart information

It had a magnetic separator, cyclonic filter and 2 secondary filters. Removed existing cyclonic filter and replaced it with the TK Filter to use it with the secondary filters.
